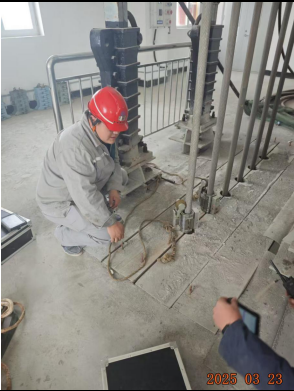
| 序号 | 报告编号 | 发布日期 | 结论 | 影像资料 |
|---|---|---|---|---|
| 1 | GX-B1598/24-6-25043 | 2025/5/9 | 实测钢丝绳有效截面积损失百分比最大为0.75%，小于5%为正常 | |

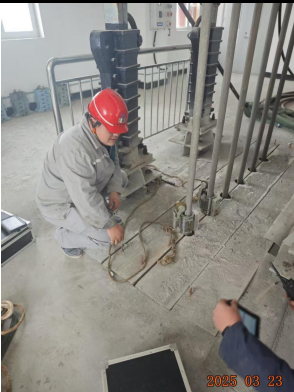
| 序号 | 报告编号 | 发布日期 | 结论 | 影像资料 |
|---|---|---|---|---|
| 2 | GX-B1598/24-6-25044 | 2025/5/9 | 实测钢丝绳有效截面积损失百分比最大为0.88%，小于5%为正常。 | |

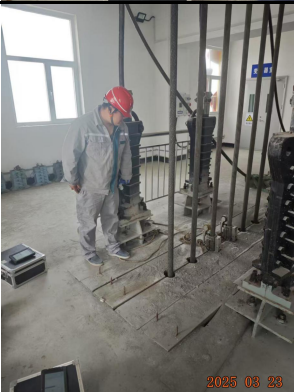
| 序号 | 报告编号 | 发布日期 | 结论 | 影像资料 |
|---|---|---|---|---|
| 3 | GX-B1598/24-6-25045 | 2025/5/9 | 实测钢丝绳有效截面积损失百分比最大为1.09%，小于5%为正常。 | |

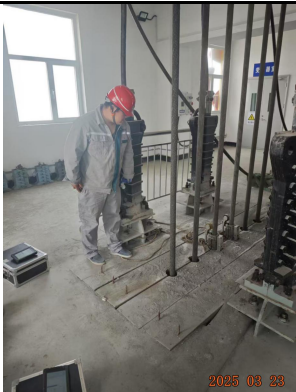
| 4 | GX-B1598/24-6-25046 | 2025/5/9 | 实测钢丝绳有效截面积损失百分比最大为0.97%，小于5%为正常。 | |

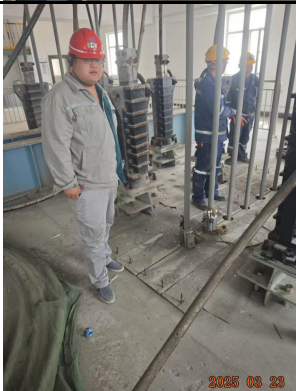
| 5 | GX-B1598/24-6-25047 | 2025/5/9 | 实测钢丝绳有效截面积损失百分比最大为1.12%，小于5%为正常。 | |

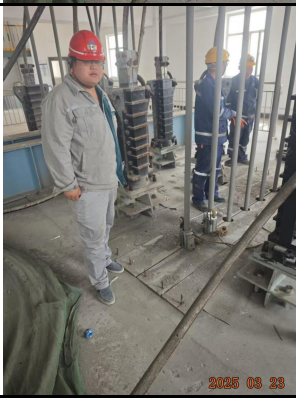
| 6 | GX-B1598/24-6-25048 | 2025/5/9 | 实测钢丝绳有效截面积损失百分比最大为1.17%，小于5%为正常 | |

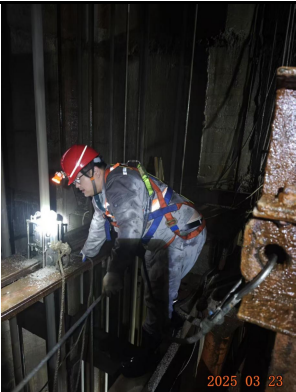
| 7 | GX-B1598/24-6-25049 | 2025/5/9 | 实测钢丝绳有效截面积损失百分比最大为1.18%，小于5%为正常 | |

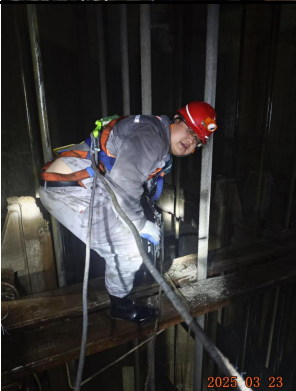
| 8 | GX-B1598/24-6-25050 | 2025/5/9 | 实测钢丝绳有效截面积损失百分比最大为1.01%，小于5%为正常 | |

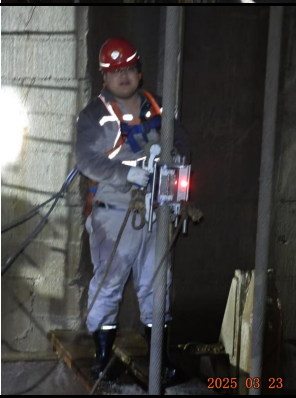
| 9 | GX-B1598/24-6-25051 | 2025/5/9 | 实测钢丝绳有效截面积损失百分比最大为1.05%，小于5%为正常。 | |

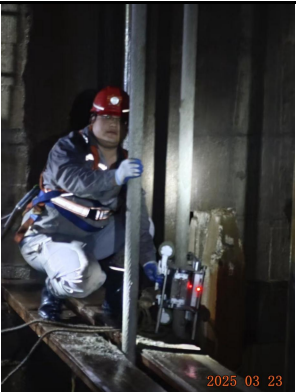
| 10 | GX-B1598/24-6-25052 | 2025/5/9 | 实测钢丝绳有效截面积损失百分比最大为1.51%，小于5%为正常。 | |

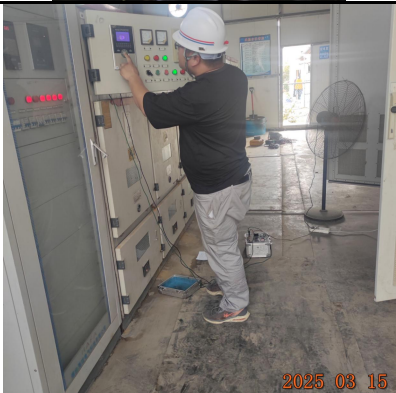
| 11 | GX-B1451/20-6-25544~25551 | 2025/5/9 | 本次共检高压开关柜8台，8台高压开关柜所检项目合格。 | |

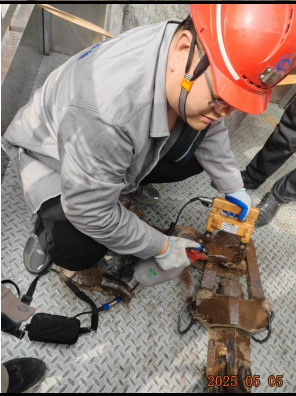
| 12 | GX-B1427/21-6-25027 | 2025/5/9 | 符合标准要求。 | |

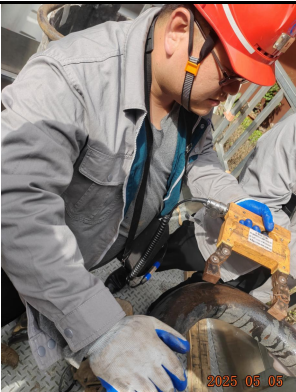
| 13 | GX-B1427/21-6-25028 | 2025/5/9 | 符合标准要求。 | | A worker wearing a red hard hat, safety glasses, and a grey uniform is working on a metal component. They are using a blue tool. The date stamp in the bottom right corner of the image is 2025 05 09. |

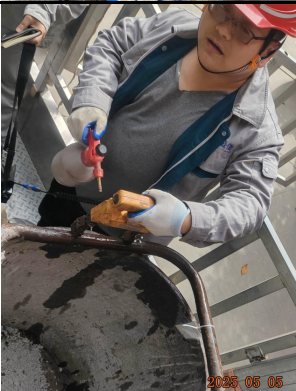
| 14 | GX-B1427/21-6-25029 | 2025/5/9 | 符合标准要求。 | | A worker wearing a red hard hat, safety glasses, and a grey uniform is working on a metal component. They are using a blue tool. The date stamp in the bottom right corner of the image is 2025 05 09. |

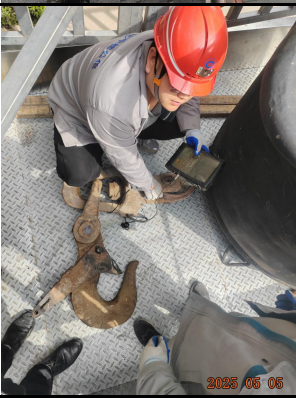
| 15 | GX-B1310/21-6-25125 | 2025/5/9 | 符合标准要求 | | A worker wearing a red hard hat, safety glasses, and a grey uniform is working on a metal component. They are using a blue tool. The date stamp in the bottom right corner of the image is 2025 05 09. |

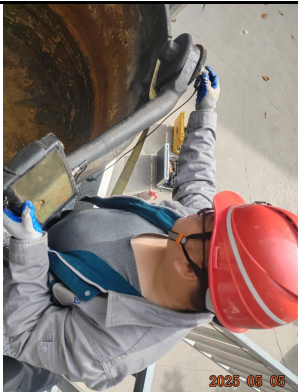
| 16 | GX-B1310/21-6-25126 | 2025/5/9 | 符合标准要求 | | |

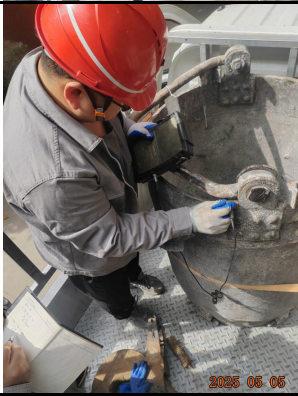
| 17 | GX-B1310/21-6-25127 | 2025/5/9 | 符合标准要求 | | |
