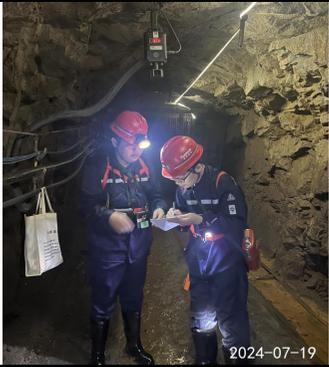
A photograph showing three workers in dark uniforms and red hard hats standing in an industrial area. They appear to be looking at something together. The background shows concrete walls and some equipment. A timestamp '2024.7.31' is visible in the bottom right corner of the image.
15	GX-B1341/24-8-24033	2024. 8. 13	综合判断：合格

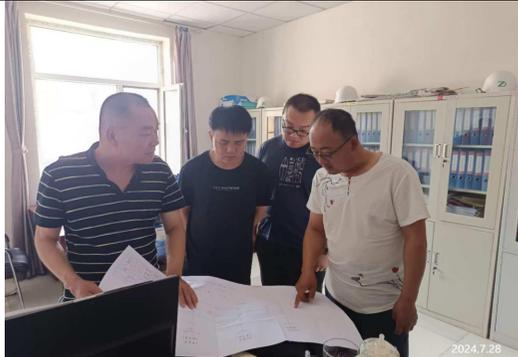
20	GX-B1343/21-8-24013	2024. 8. 13	<ol style="list-style-type: none"> 1. 矿井总风量：893.3 m³/min； 2. 主通风机风量：1209.6 m³/min； 3. 矿井通风阻力：236.2 Pa； 4. 风量（风速）合格率：100%，大于65%，合格； 5. 风质合格率：100%，大于90%，合格； 6. 作业环境空气质量合格率：100%，大于60%，合格； 7. 矿井有效风量率：67.9%，大于60%，合格； 8. 风机全压效率：86.0%，大于70%，合格； 9. 风量供需比：1.54，符合$1.32 \leq \beta \leq 1.67$要求，合格； 10. 综合指标：91.4%，大于72%，合格。
